The Impact of Nanoparticles Implementation on Conservation of Heritage Buildings (Overview the Nanocathedral Project)

Nano Cathedral Project:

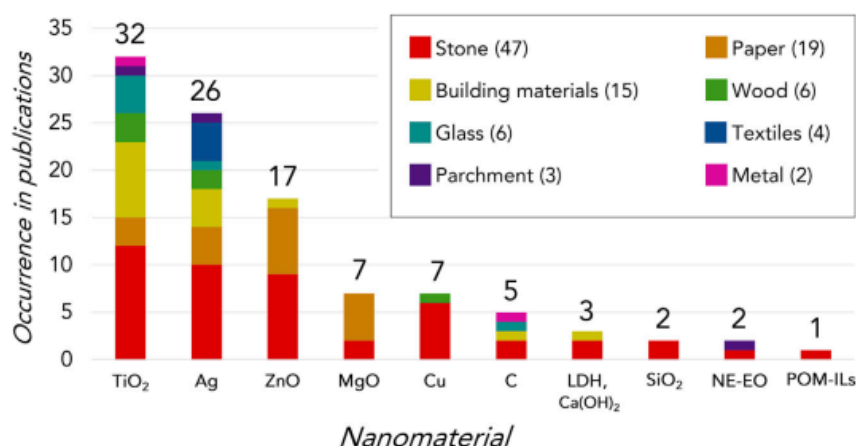
Frequency of studies of a nanomaterial for each type of heritage item substrate

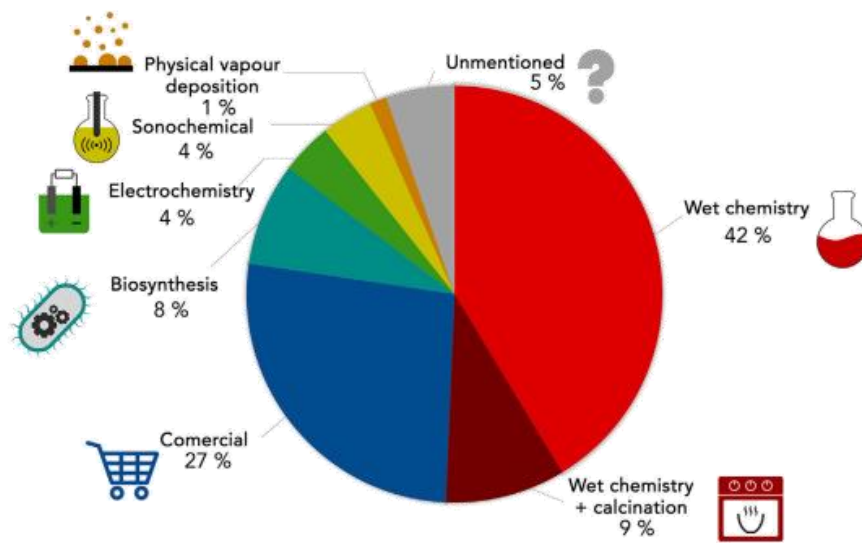
Origin of the antimicrobial nanomaterials used in heritage conservation

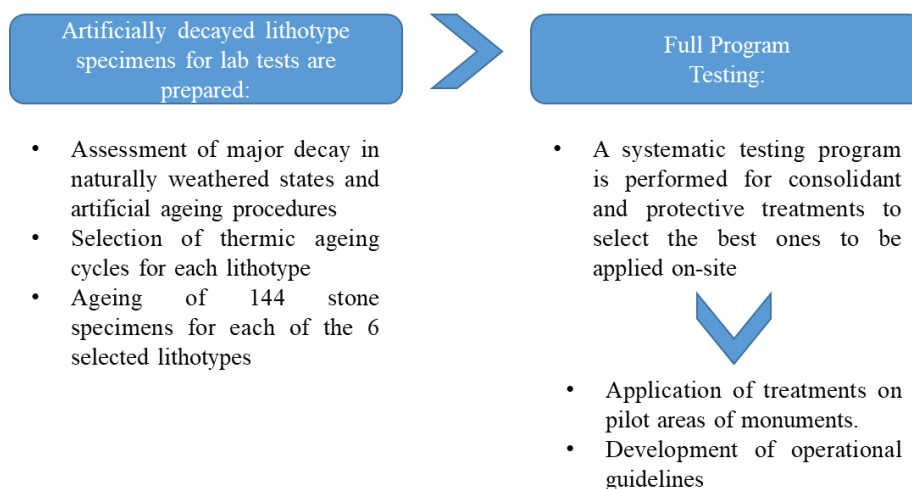
Survey on commercial and research stone consolidants and protective coatings

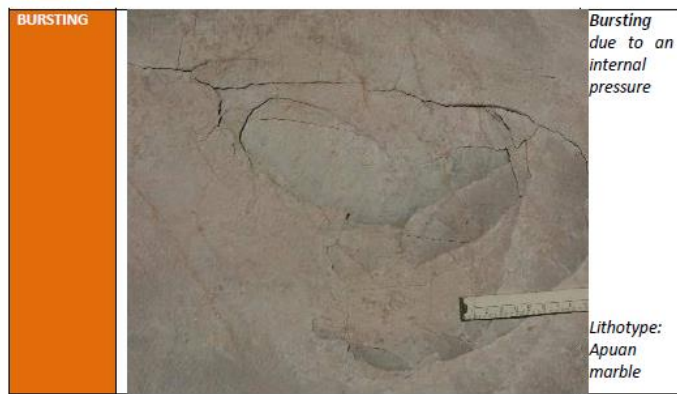
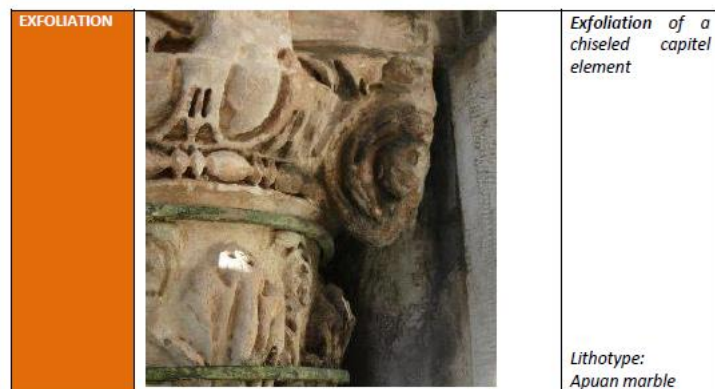
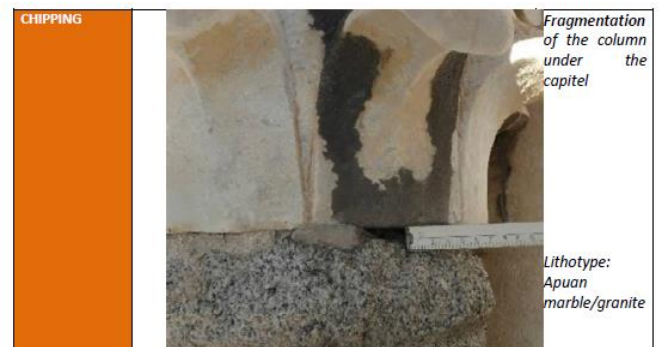
The surfaces of the cathedrals are susceptible to degradation due to various factors, including climatic conditions and air pollutants. These factors contribute to the formation of cracks on the surface, such as hair cracks, star-shaped cracks, and craquelure. Additionally, delamination, which is the separation of layers or fragments from the surface, can be observed. Disintegration of the stone may occur in the form of crumbling, sugaring (formation of powdery residue), and granular disintegration. These degradation phenomena pose challenges to the preservation and conservation of the cathedrals' stone surfaces and emphasize the need for effective treatments and interventions to mitigate further deterioration. The Nano-Cathedral project aims to address these issues through the development and application of innovative nanomaterials for consolidation and protection.

The material of the cathedrals is subject to erosion phenomena, which gradually wear away the surface. Impact damages and gaps contribute to the loss of material, leading to structural vulnerabilities. In certain areas, pitting, which is the formation of small cavities or depressions, can be observed. Black crusts, likely formed from the deposition of pollutants and biological growth, can be found in various areas. Staining caused by the oxidation of iron and bronze is also present. Additionally, incrustations and patinas, which are layers of accumulated debris or corrosion products, may be observed. The surfaces are further affected

The biological colonization of the monument is a significant concern, with various forms of organisms impacting the surfaces. Algae, lichens, moss, and plants can be found growing in the joints between the stone slabs. These organisms not only detract from the aesthetic value of the monument but also contribute to the degradation and deterioration of the stone materials over time. Their growth can lead to increased moisture retention, which promotes the development of cracks, disintegration, and other forms of damage. Effective measures for controlling and preventing biological colonization are crucial to the preservation and maintenance of the monument's surfaces. The Nano-Cathedral project, with its focus on developing nanomaterial-based treatments, aims to provide innovative solutions for combating biological colonization and minimizing its detrimental effects on the heritage structures.

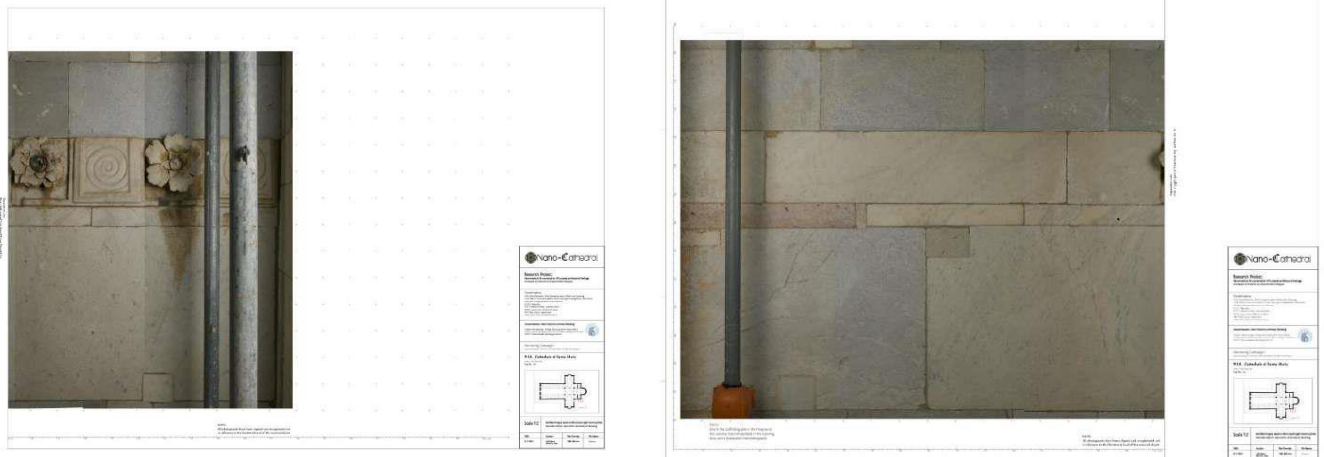
The trial area was 3D-scanned using a Structured-Light-Scanner Comet L3D with a resolution of 0.3 mm. The scanning process involved capturing 57 individual scans of the area. A 800mm lens was used during the scanning process to ensure detailed and accurate data capture. The structured-light scanning technique involves projecting a pattern of structured light onto the surface and capturing the deformation of the pattern, which allows for the creation of a detailed 3D model of the scanned area. The resulting scans provide a comprehensive representation of the geometry and surface details of the trial area, facilitating further analysis and documentation of its condition.

To ensure comprehensive photographic documentation of the trial area, the process was divided into four separate shots to capture the entire width of the area. All photographs, except for the UV documentation, were taken using a modeling light.

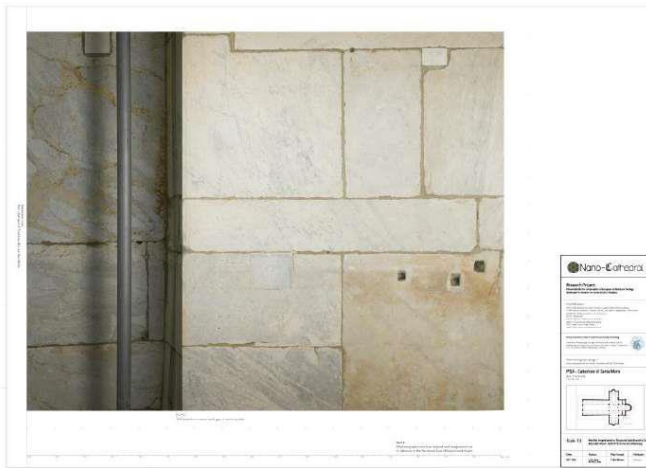
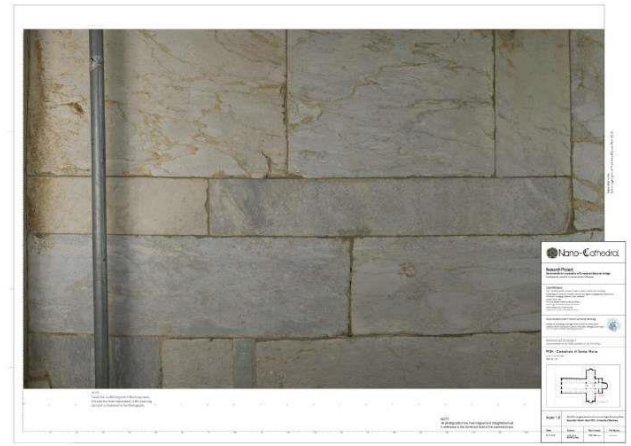
The documented area has dimensions of 392 x 200 cm and consists of a combination of Apuan marble, Monte Pisano marble, and Bloch Limestone. 3D-scanning: Structured-Light-Scanner Comet L3D in a resolution of 0.3 mm (800mm lens). The area was scanned with 49 single scans. Due to the Trial Area's width, all photographic documentation had to be subdivided into four single shots. All photographs except UV were done with modeling light. There might occur changes in color at the junction of the single shots (www.nanocathedral.eu).

Color photography: single shot taken with Hasselblad H2 with iexpress CFH digital body (39 megapixel); lens: Hasselblad HC 50 mm; ISO: 50; focal ratio: F/11; exposure time: 1/125 sec.; measurement mode: centerweighted (www.nanocathedral.eu).

Flash system: Broncolor grafit A4 with stereo flash; setup of right flashbulb: soft box 60x100 cm; focal ratio: 5.0; setup of left flashbulb: soft box 60x100 cm; focal ratio: 5.0; taken with single flash impulse (www.nanocathedral.eu).

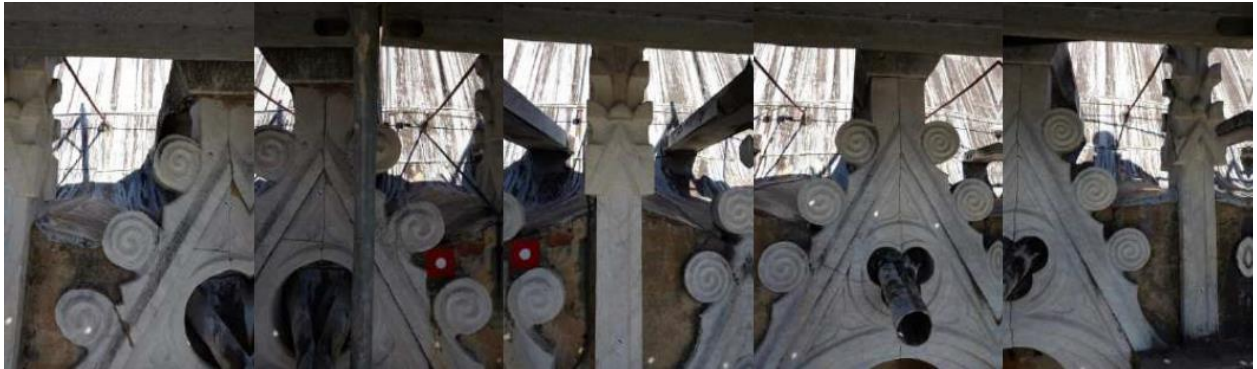
3D-Scanning: The area was scanned using a Faro Focus X120, which is a terrestrial laser scanner. The scanner has a resolution of 3 mm on a 10 m distance, with a specified resolution of $\frac{1}{2}$ and quality of $\frac{1}{4}$. Four single scans were performed to capture the area.

Color photography: For color documentation, single shots were taken using a Canon EOS 5D Mark II camera with a 21-megapixel resolution. The lens used was a Canon 30mm lens. The camera settings were as follows: ISO 100, focal ratio of F/11, exposure time ranging from 1/80 to 1/125 sec. The measurement mode used was evaluative metering. The color photographs were taken during daytime without the use of a flash system.

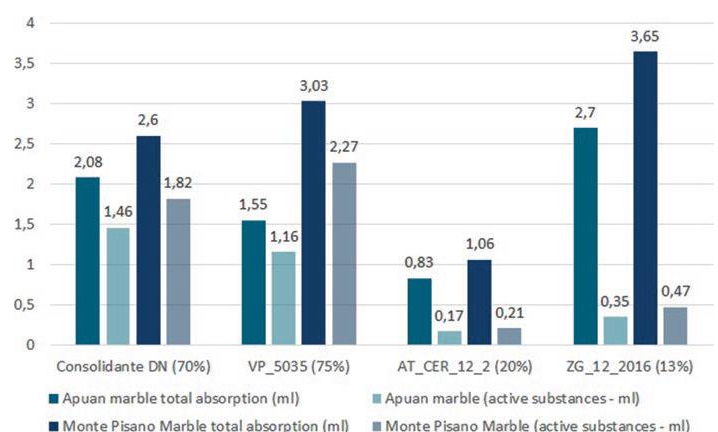
Consolidants: comparison between volume of solution and volume of active substances absorbed by the two stones (test areas 10 cm × 10 cm)

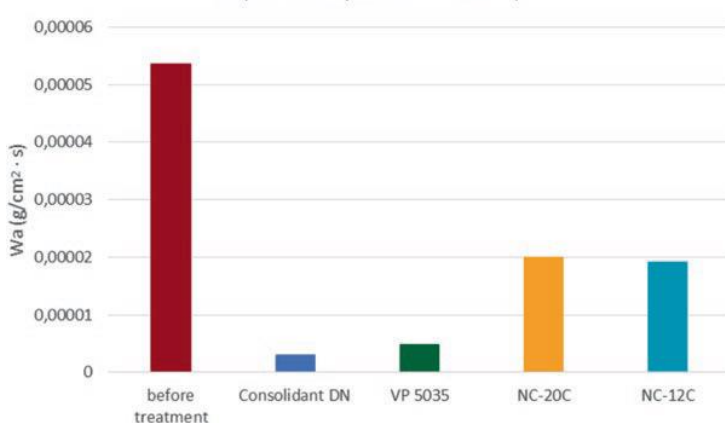
Karsten tube- South (dome)- Monte Pisano limestone

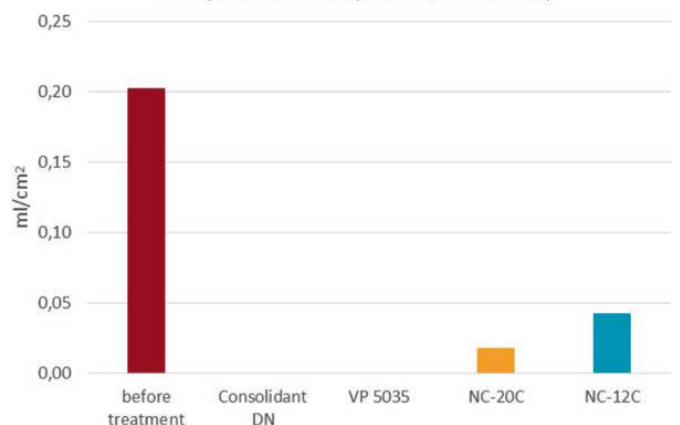
Contact sponge measurement before and after the application of protectives on Carrara marble

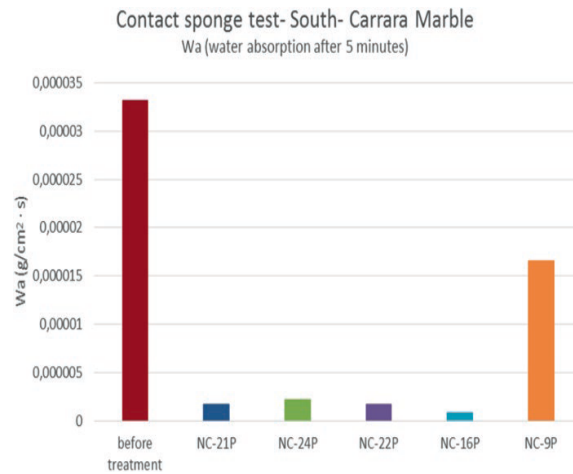
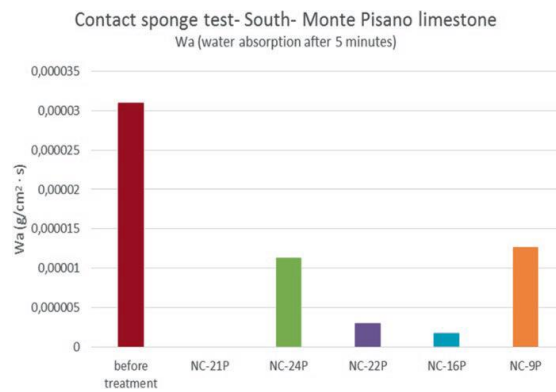
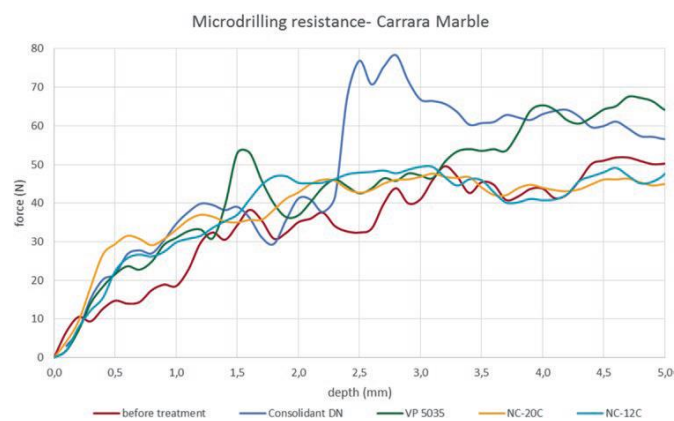
Trend curves of mechanical resistance before and after the application of consolidants on Carrara marble

Contact sponge
measurement before
and after the
application of
protectives on Monte
Pisano limestone
